'LAKES OF ODISHA' SERIES-1

RAPID STATUS APPRAISAL: ANSHUPA LAKE

21 December 2024

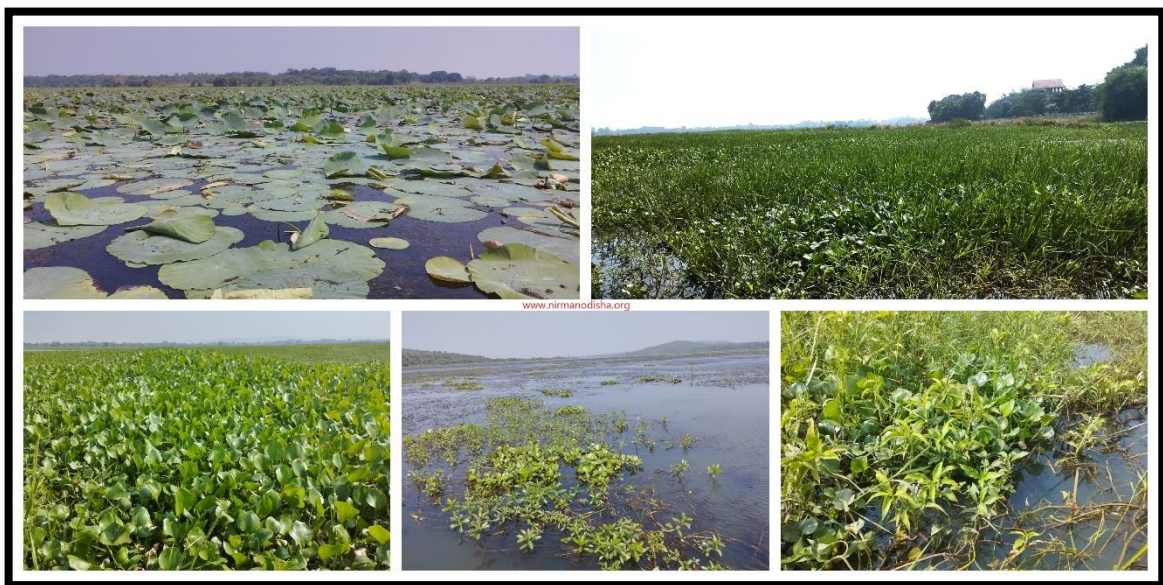
Lotus & weeds covering Anshupa

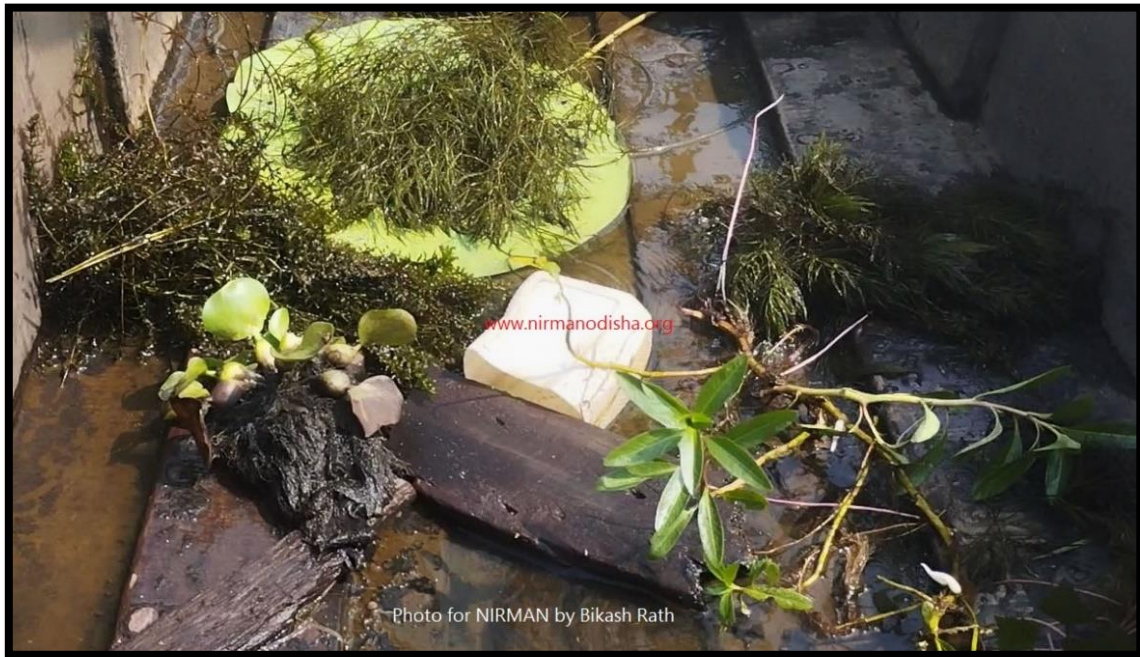
Some major weeds of Anshupa (seen in this image are the locally called Chalunia dala, Chingudia/Kanta dala, Nanda dala, Naga dala, and Kacharingi, with Pani singada, as shared by Sudam Dalei & Budhibaman Dalei)

The existing boating area should be extended upto the Bishnupur hill; both manual & mechanical de-weeding measures be taken on a regular basis engaging the local fishers; and effective propagation of the fish species of conservation concern should be initiated.

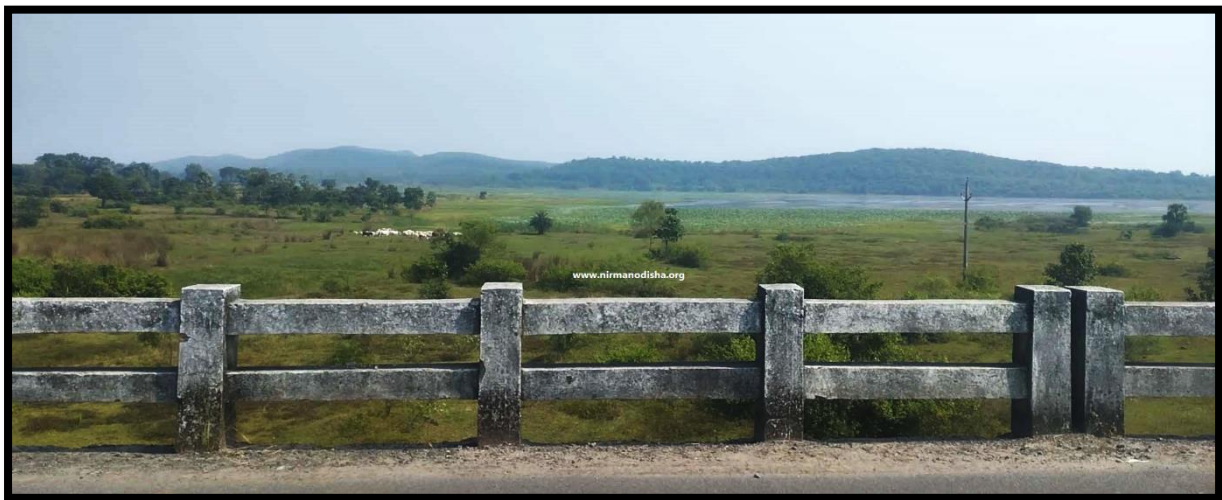
A part of the Khandak nala joining the Anshupa lake, as seen from the bridge. Mahanadi flood water occasionally enters the lake also through this route.

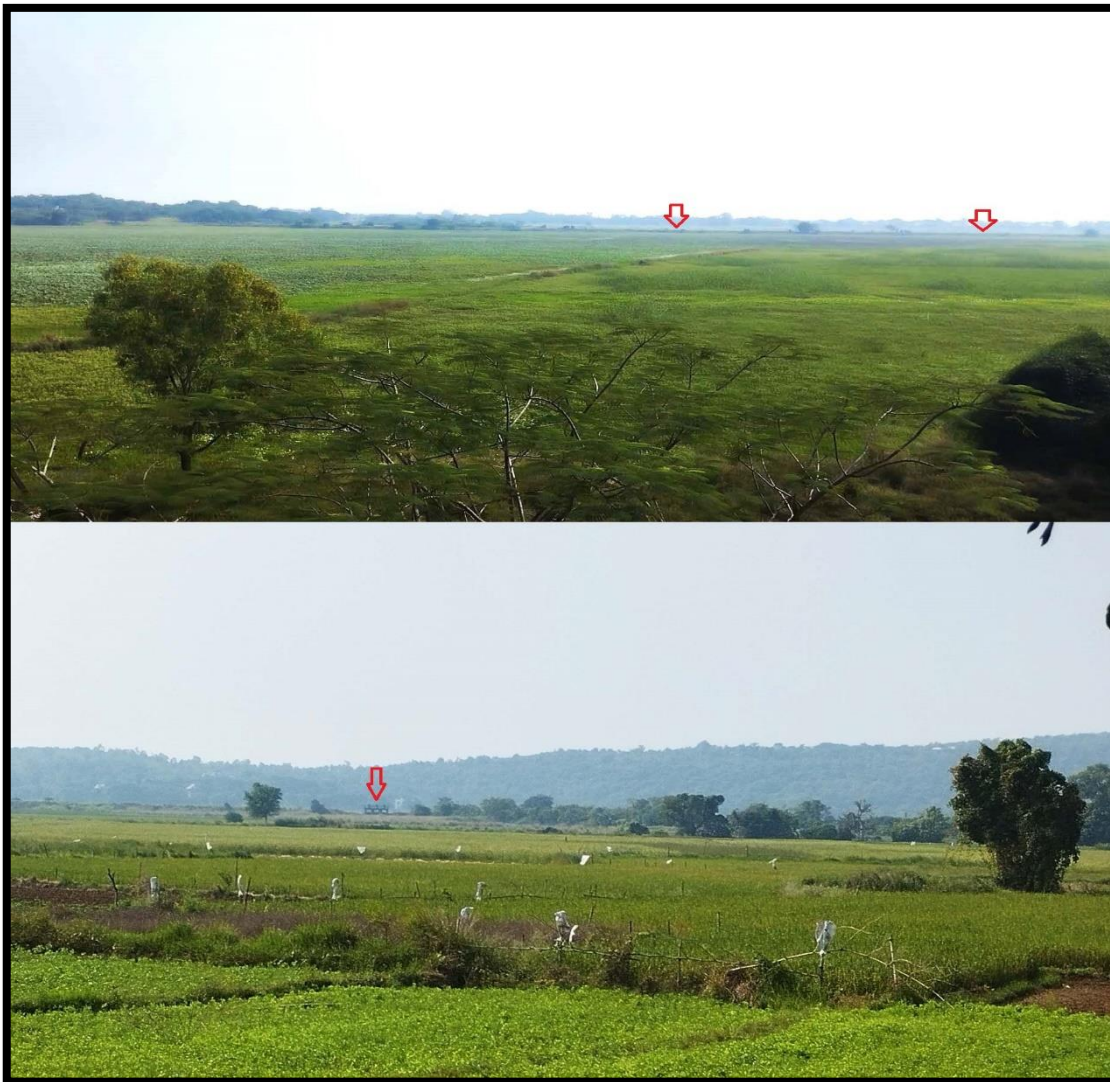
Budhibamana Dalei of Subarnapur narrates another interesting dynamics. He says, the spread of lotus in the lake suppresses the growth of *pani singada*(Water chestnut, an economic species), but earlier when the Dahaliani embankment was about 10 ft high the flood water entering the lake from Mahanadi would first submerge not only the lotus cover but also other invasive weeds like the water hyacinth which in turn would rot if this submergence continues for a week or so, and this is how the weed cover vanishes. Once gone, it used to take about two years for the lotus to regain its coverage; but after the height was increased to about 25 ft in 1999(?) and this natural hydrological mechanism was further controlled for other purposes, the ecosystem dynamics was disturbed¹⁸.

The Dahaliani embankment from the lake side (upper) and Subarnapur side(lower) as marked by the red arrows. The arrow on the lower image shows the sluice gate.

¹⁸ B.N.Das(*op.cit*) explains in his M.Tech dissertation report that the Kabula nala(channel) used to connect the lake on one side, and during high floods Mahanadi water entered(inflow) the lake through this channel(there are two other inflow routes like the Khandak nala and the Mayuree nala) and when the flood water receded the excess water from Anshupa returned through this nala as outflow. After construction of the embankment & sluice gate this hydrological dynamics was disrupted. (Vide sub-sections 2.15 & 3.1.2 of his report)

The long-term ecological impacts of all the broad measures previously taken without finer considerations should be reviewed and actions should be taken accordingly. Like, the impact of the existing embankments & sluice gates has been quite questionable and the long-term impact of Grass Carp is also debatable given its adverse impacts observed in the Great Lakes²³. Remedial measures should be taken for sustainable improvement of the lake status with a long term vision.
